Application ID 13-1544634 Injection Molding Machine M&V Report

August 5, 2016

The Cadmus Group, Inc.

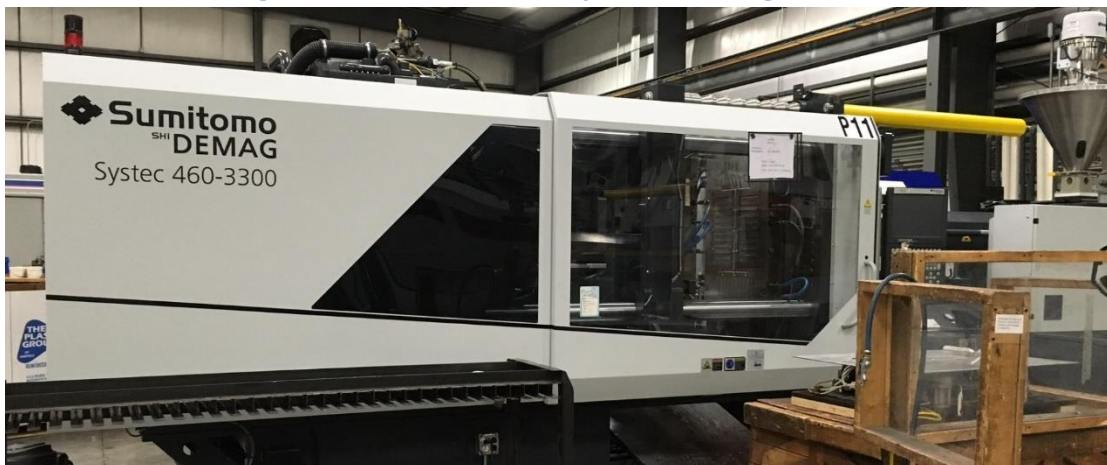
Figure 1. Installed 500-ton Injection Molding Machine

During the site visit, Cadmus photographed the injection molding machine and associated nameplate: Figure 1 shows the installed, 500-ton, injection molding machine; Figure 2 shows the nameplate.

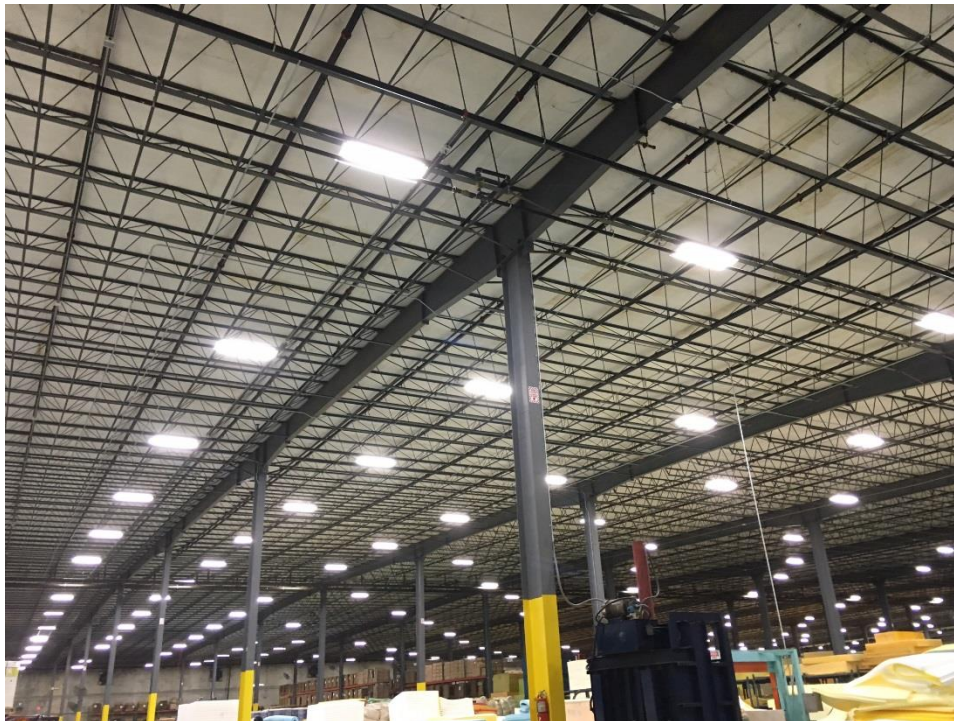
Figure 1. Main Warehouse Lighting Fixtures

center warehouse space with ~40' ceilings, and two spaces on either side with ~20' ceilings. Figure 1 shows lighting fixtures in the main warehouse space.

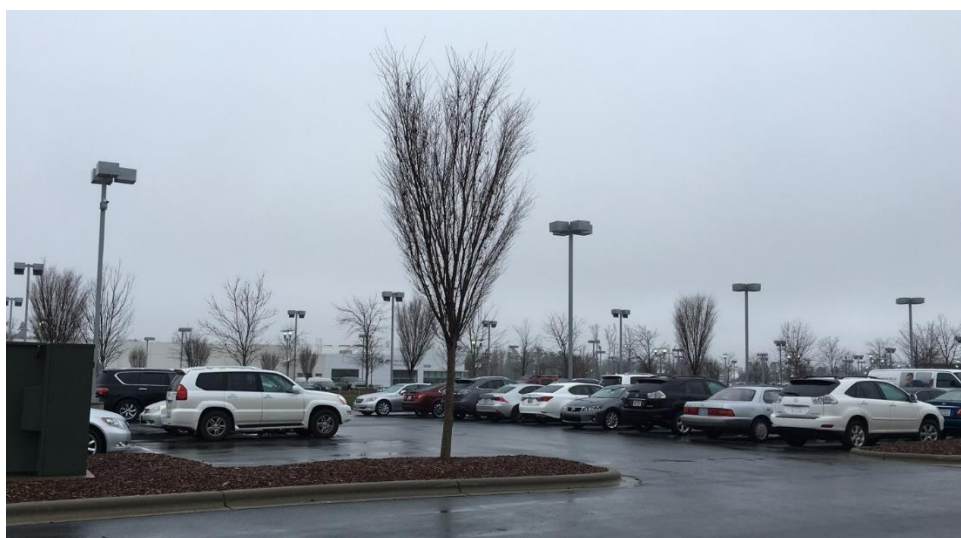
Figure 1. [redacted] Parking Lot Fixtures

Cadmus also photographed installed parking lot fixtures at various locations. Figure 1 shows the parking lot at [redacted]. Figure 2 shows an energized lamp at [redacted] (which was forced on during the power meter installation). Figure 3 shows a two-fixture pole at the [redacted]. Figure 4 shows the four-fixture pole at [redacted].

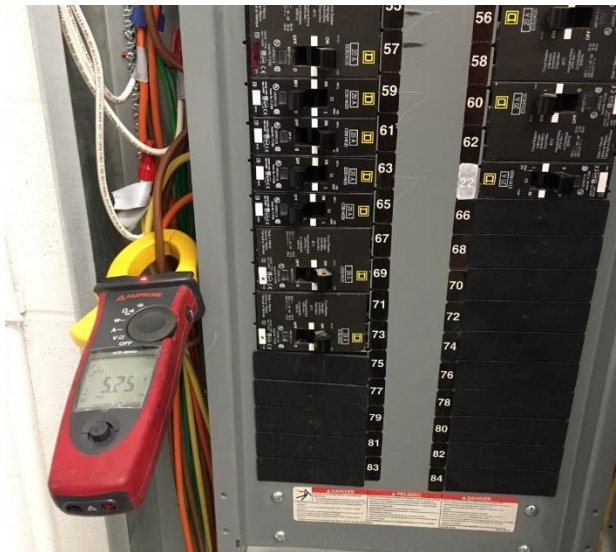
Figure 5. [redacted] Lighting Circuit Metering – Current Reading

Figure 5 shows the reading during Cadmus' verification of the circuit load.

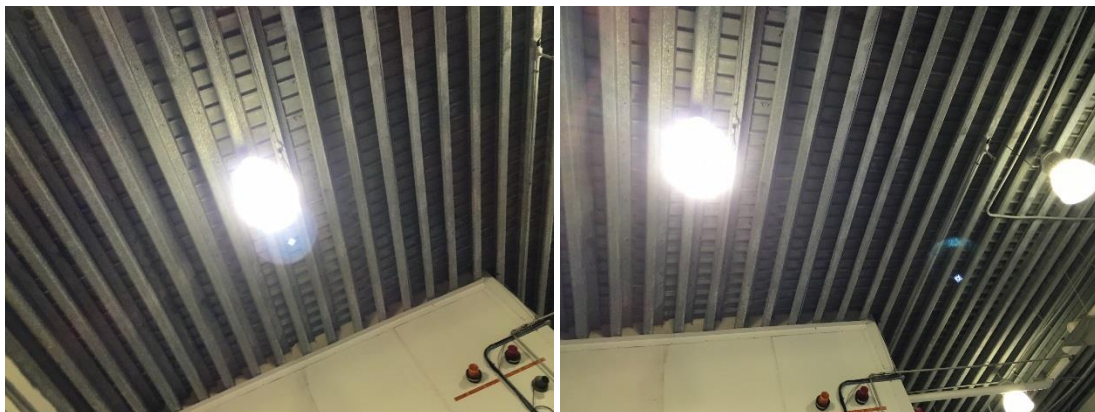
Figure 1. Refrigerated Warehouse LED Lighting Fixtures

After completing the lighting survey, Cadmus performed a walkthrough of the facility to verify and count the new lighting fixtures. Because the lighting fixtures are located in cooler or freezer spaces with daily spray-downs, no light loggers could be installed. Figure 1 shows installed LED lighting fixtures in the refrigerated warehouse space. Table 4 summarizes the installed lighting fixture counts.

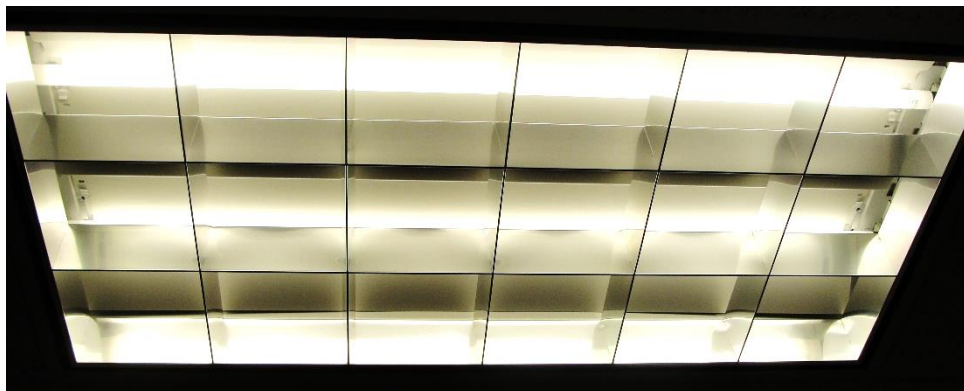
Figure 4. Installed 2-Lamp 2-Foot by 4-Foot T8 Troffer

OverAll (L)	Width (W)	Height (H)	Mounting (M)
9.5 "	1.3 "	1.0 "	8.9 "
9 1/2	1 3/10	1	8 9/10
24.1 cm	3.3 cm	2.5 cm	22.6 cm

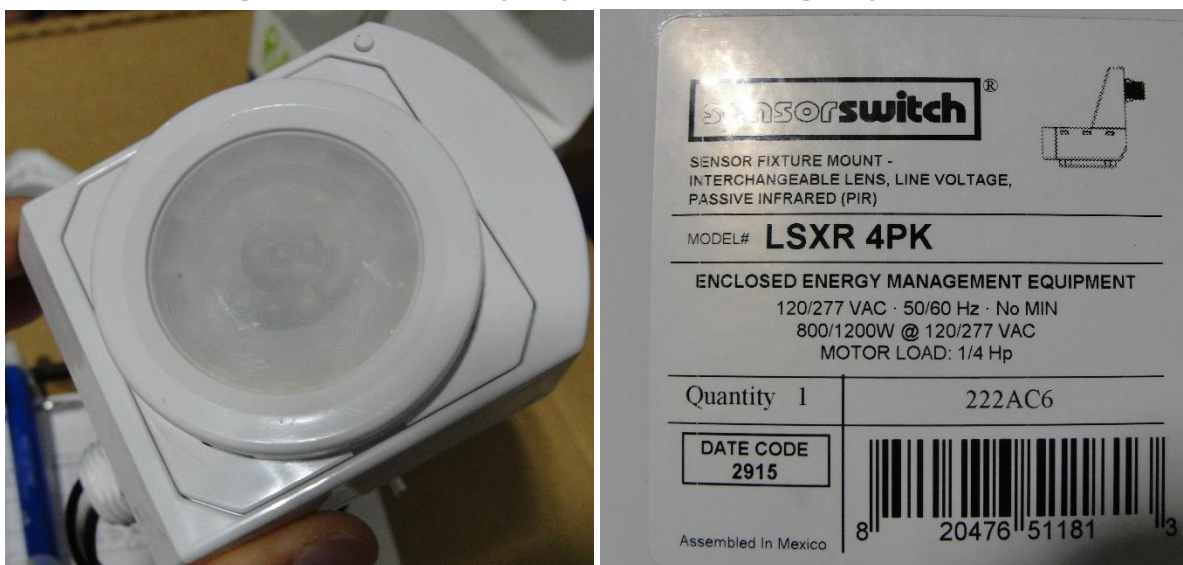
After completing the lighting survey, Cadmus performed a walkthrough of the facility to verify the new lighting fixture types and to install light loggers. Figure 1 shows an installed LED high bay lighting fixture in one of the warehouse spaces (left) and the fixture make and model number (right). Figure 2 shows the ceiling-mounted occupancy sensors that were installed with the LED high bay lighting fixtures.

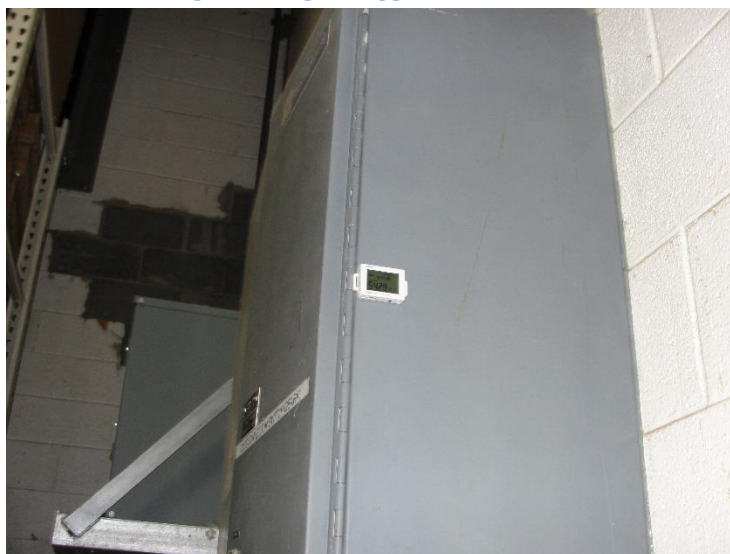
Figure 3. Light Logger Location #4

Figure 3 shows one of the locations where Cadmus installed a light logger.
